CASCADING NORTHERN RAKE DETAILS PBR ROOF AT STEEL LINE	5/6/14
---	--------

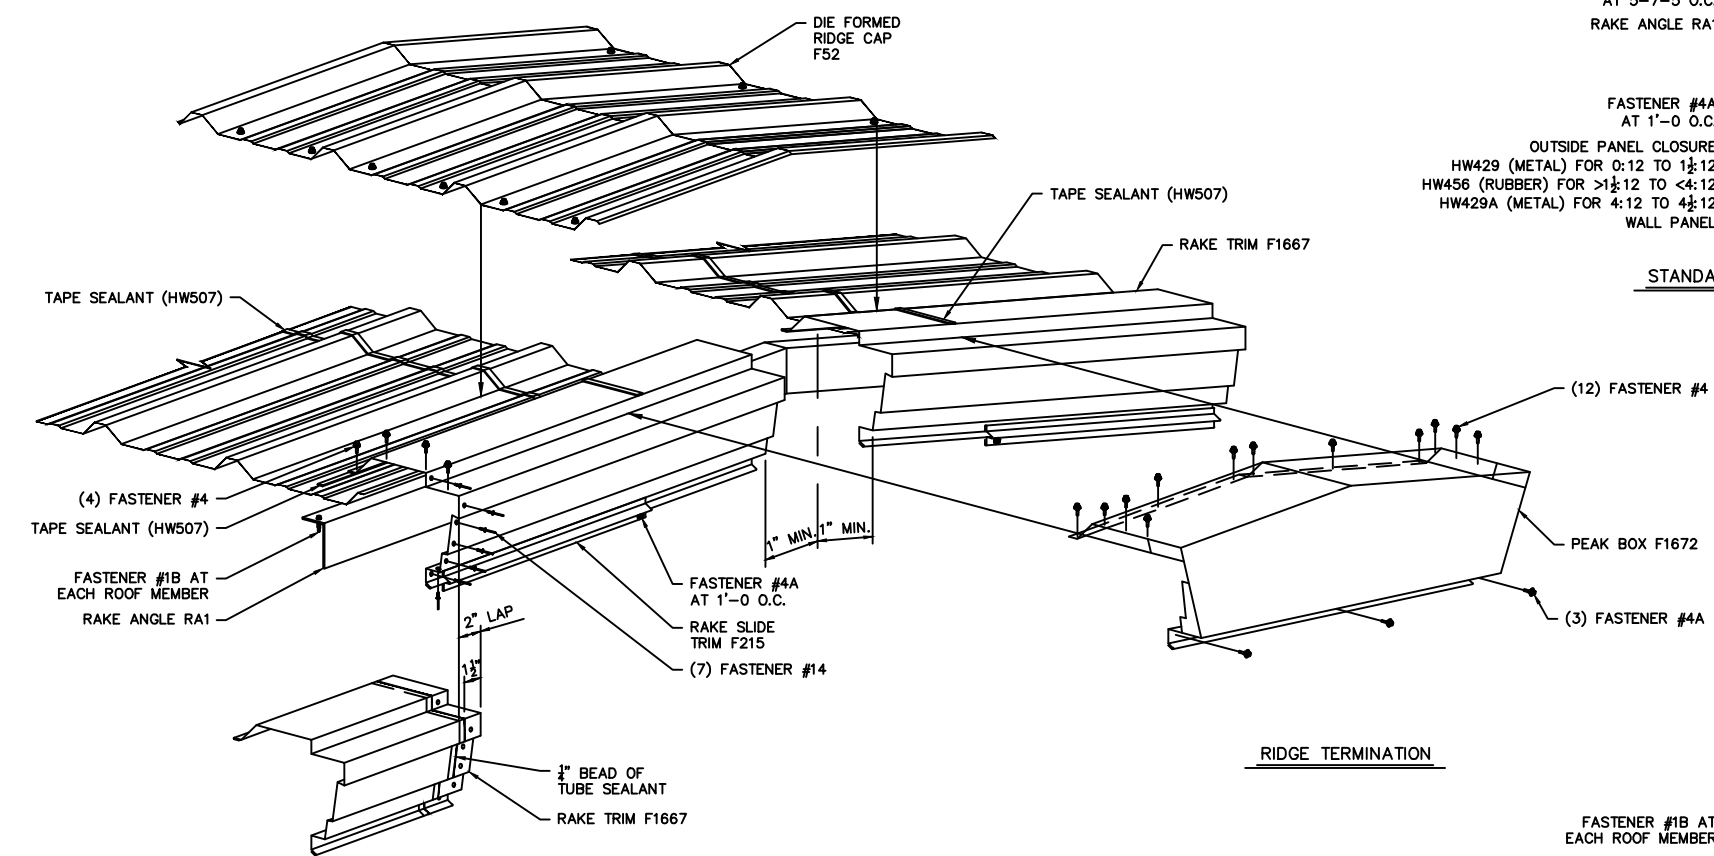
RAKE TRIM LAP

RIDGE TERMINATION

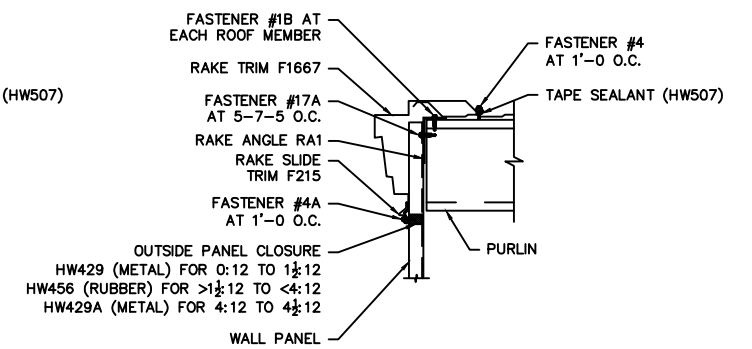
STANDARD SECTION AT PBR WALL  
GABLE RUN GREATER THAN 100'-0

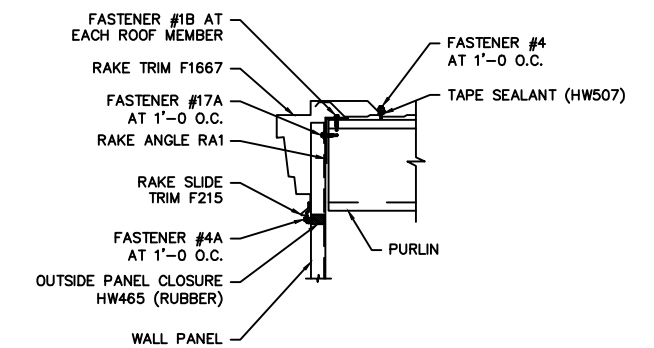
STANDARD SECTION AT AVP WALL  
GABLE RUN GREATER THAN 100'-0
